# Modern Byelorussian Architecture 1920-1930 – European Features and Regional Peculiarities

**Evgeni Morozov**  
*Minsk, Belarus*

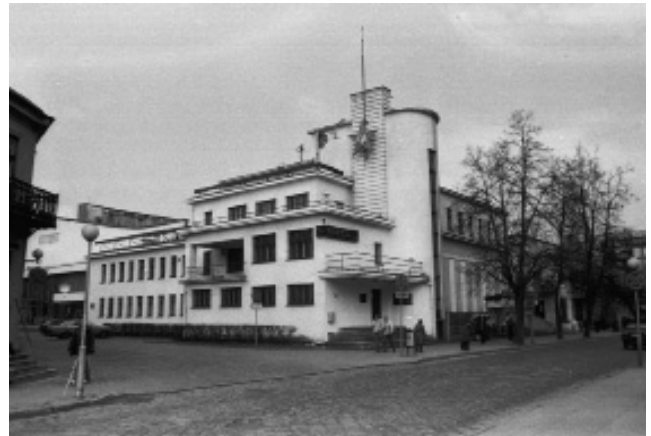
**1.** Marksman's House, Orzeszkowa street, Grodno; 1935, designed by A. Dubanovich. Photo by the author

Orzeszkowa street, designed by A. Dubanovich (Fig. 1). Its architectural exterior clearly proves the application of this rule. The spatial layout of the building was designed around the central staircase, extending above the roof, from which hallways with hotel rooms run off in two directions – and this can be clearly seen in the shape of the building. The semicircular staircase, a characteristic feature of functional

architecture, resulted from the fact that a ramp was introduced, which was rather unusual in residential buildings. A vertical length of windows was intended to highlight the interior structure of the building.

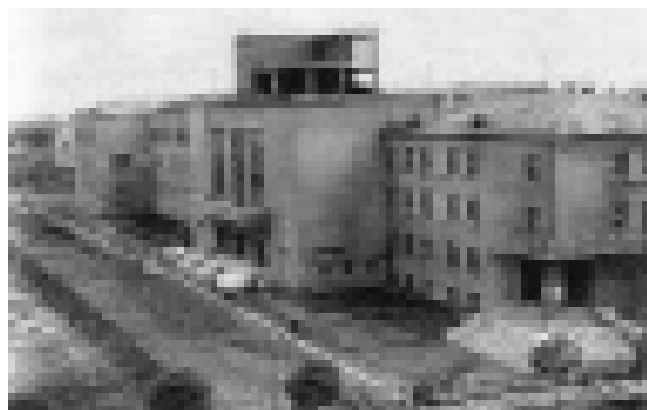
**4.** Byelorussian National University in Minsk (1930), main building; architect G. Lavrov. Source: I. M. Куркоў, *Мінск незнаемы 1920-1940, аўтар-укладальнік, Мінск: Ураджай, 2002, p. 47*

so they were rarely used in practice. One of the few examples of roof terrace is the main building of the National Byelorussian University in Minsk (Fig. 4). Most frequently, roof terraces designed by architects were in practice replaced with small gradient sloping roofs (e.g. the buildings of clinical hospital in Minsk and numerous other buildings erected at that time).

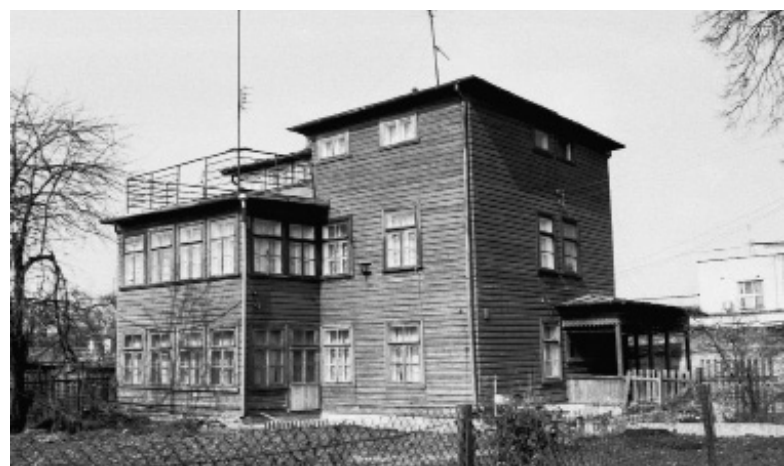
**5.** Residential building in Grodno (Osipienko street) (1920-30); architect unknown. Photo by the author

In the western areas of present-day Belarus (unlike in the eastern regions), roof terraces were designed not only in public buildings but in residential houses as well. In Grodno, the house in Osipienko street has a big terrace above its two-floor living segment, with metal railings of typical modern line (Fig. 5). The building itself, however, had a timber frame, and the terrace was in fact a single-slope roof with a small gradient.

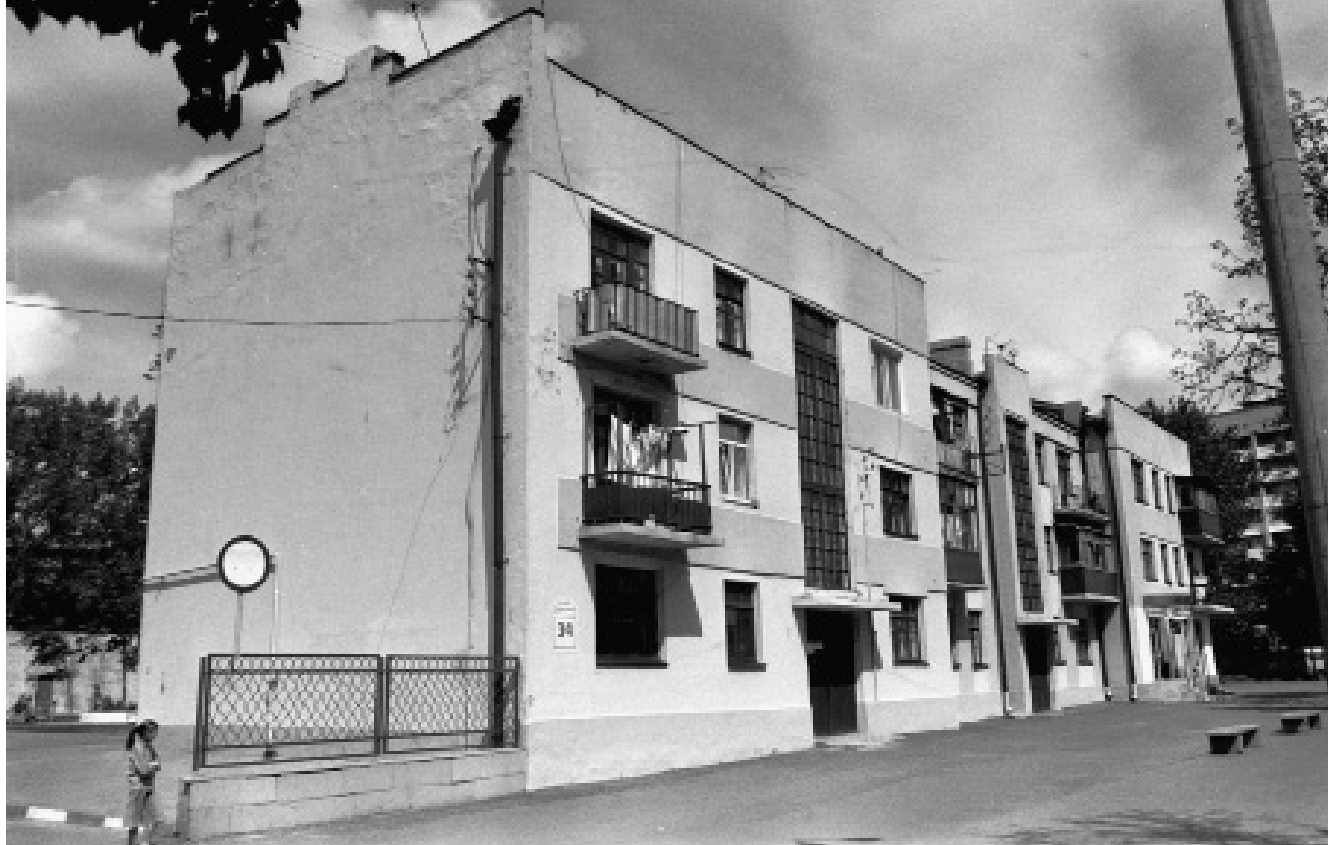
6. Residential building in Mogilev (34 Pionierska street) (1920-30); architect unknown. Photo by the author

Flat roofs were extremely fashionable, and even if a house did have a sloping roof, it was hidden behind a high balustrade to hint a flat roof and a terrace. This was the case with the house in Mogilev, at 34 Pionierska, where the balustrade does not stand out against the façade, linking with it by decorative stripes (Fig. 6). The polyclinic building in the town of Hlybokaye has a gable roof covered with metal sheet, with a gradient so small it can hardly be seen from street level (Fig. 7).

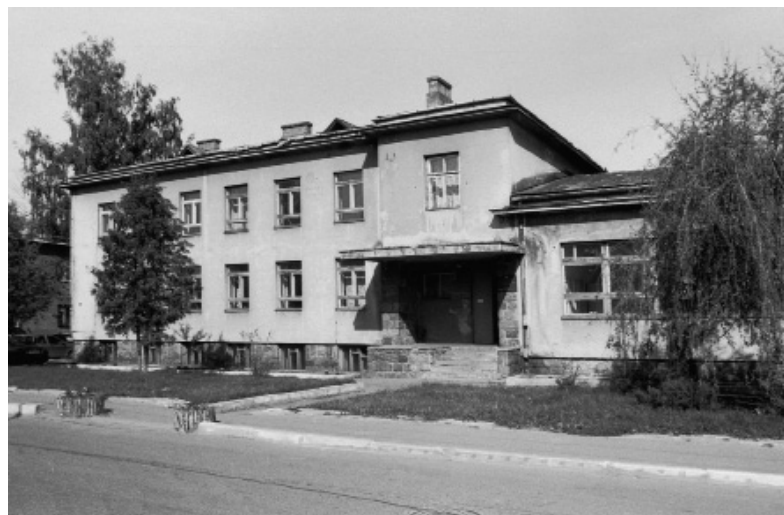
7. Polyclinic building in Hlybokaye (1920-30); architect unknown. Photo by the author

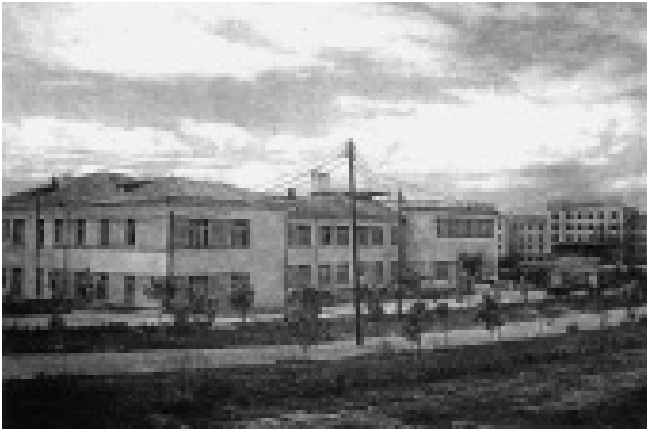
**8.** *Clinical hospital in Minsk (1931); architect G.L. Lavrov. Source: I. M. Куркоў, Мінск незнаемы 1920-1940, аўтар-укладальнік, Мінск: Ураджай, 2002, р. 199*

Another fashionable modernist attribute was ribbon windows. They also became a popular architectural motif, although interpreted in different ways. For example, the windows of the clinical hospital in Minsk were arranged as ribbons with wide brick walls between particular windows, all in the form of a shallow recess and slightly darker in colour (Fig. 8). This method of linking windows into strips by means of recess and colour was commonly used in many modern buildings at the time.

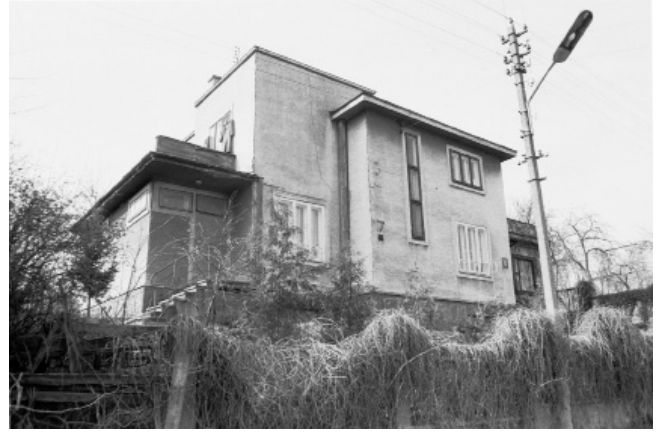
**9.** *Villa in Grodno (10, Kirpiczna street, 1934); architect unknown. Photo by the author*

The layout of the rooms in the luxurious villa at 10, Kirpiczna in Grodno, , provided living comfort with relatively small floor area (Fig. 9). The hall, the living room and bedrooms were,

however, big enough to be connected by a system of passages and hallways. There was a garage in the ground floor. The design included built-in closets and a separate walk-in closet, where windows were placed close to the ceiling, directly above the shelves and hanger rods. The plot is situated on a slope, so the architect designed a system of steps for the residents' convenience and retaining walls to support terraces with lawns and flower beds. Undoubtedly, these features constitute an important element of the composition, and were made of quality reinforced concrete, thanks to which they have survived for 70 years.

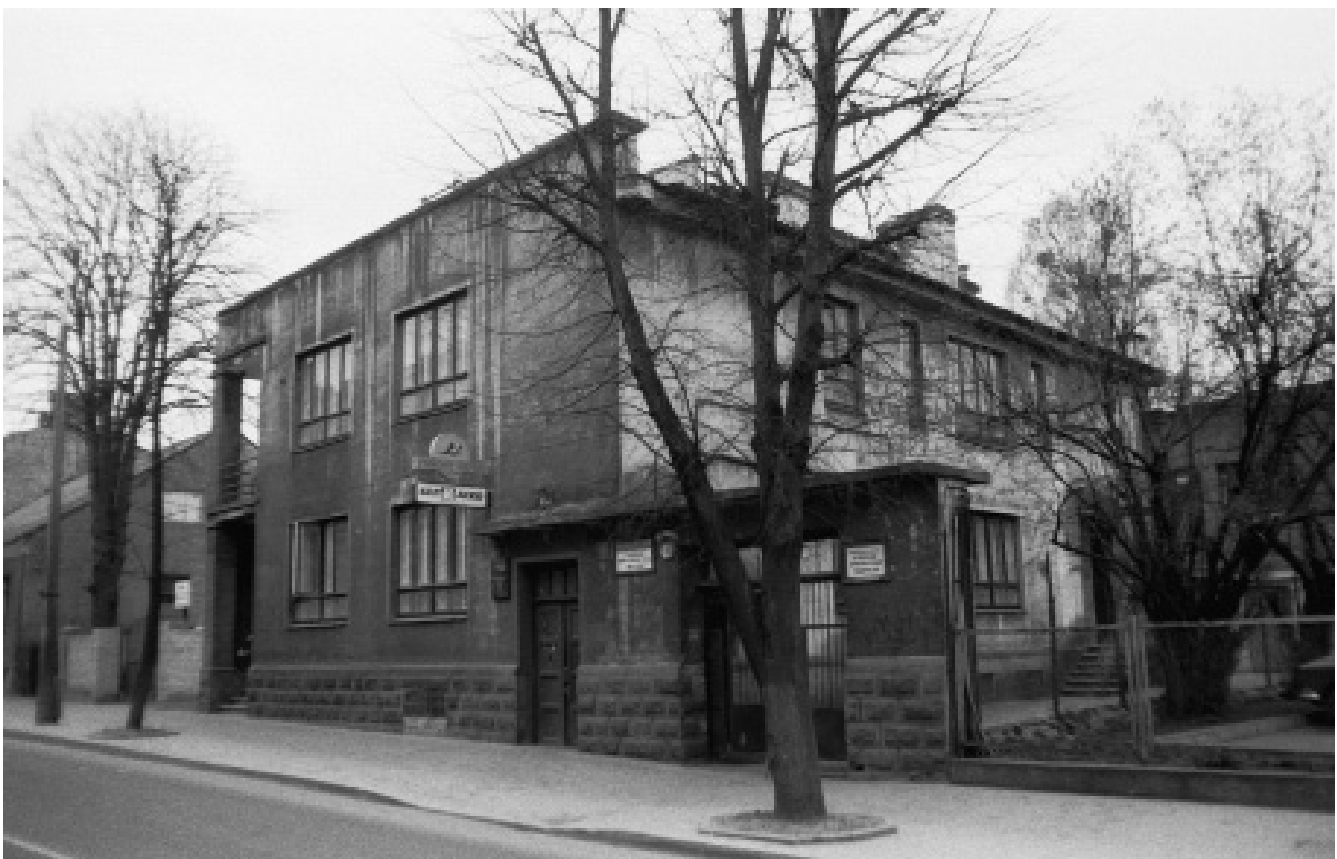
**10.** *Villa in Grodno (18, Lenin street, 1920-30); architect unknown. Photo by the author*

High-quality architectural finish can also be seen in the luxurious villa in Grodno, at 18, Lenin street (Fig. 10). The plasterwork of the building, like in many other "luxury trend" buildings, was enriched with crystalline schist

which added some distinct lustre to it. The front foundation was covered with granite blocks. The gateway to the premises is quite unusual: it is compositionally incorporated into the building, so they both form a unity. Another example of the "luxury trend" is the villa in Kobryn at 4, Suvorov street (Fig. 11). It has an interesting feature of a flowerbed incorporated into the structure of the plinth, both built of the same material.

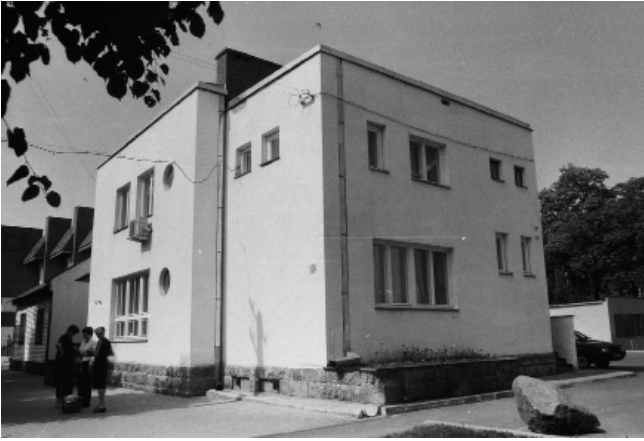
**11.** Villa in Kobryn (4, Suvorov street, 1930); architect unknown. Photo by the author

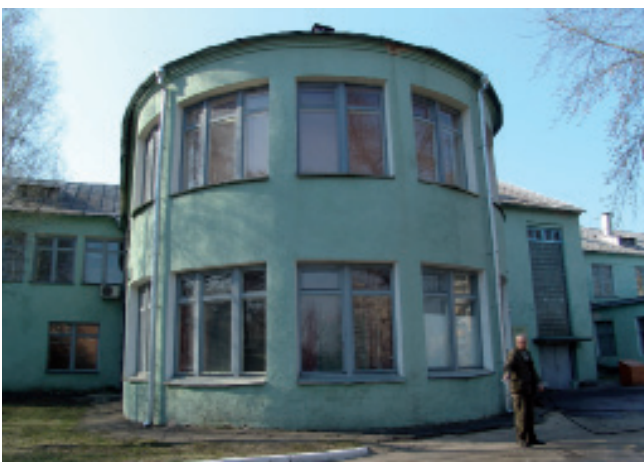
**12.** Former school in Minsk (96, Mayakovsky street, 1930); architect S. Borodin. Photo by the author

A good example of this “simplified Constructivism” is the former school building in Minsk, at 96 Mayakovsky street (Fig. 12). The sketch design made in 1933 assumed brick load-bearing walls, wooden beam floors and high gable roofs, together with two terraces: one of them with a doorway to the library, the other with a doorway to the gym (Fig. 13). However, the concept of terraces was given up while layout plans were being made,<sup>4</sup> which definitely changed

the shape of the building. What remained of the characteristic features of the original concept was wide windows with recessed walls between them giving the impression of ribbon windows. The unusual, elongated layout of the building was based on the principle of functionality and good passage of sunlight, which is why it can be called a Constructivist building.
