Problems of Heritage Preservation of Interwar Architecture in Kosice

Zuzana Labudová
Kosice, Slovakia

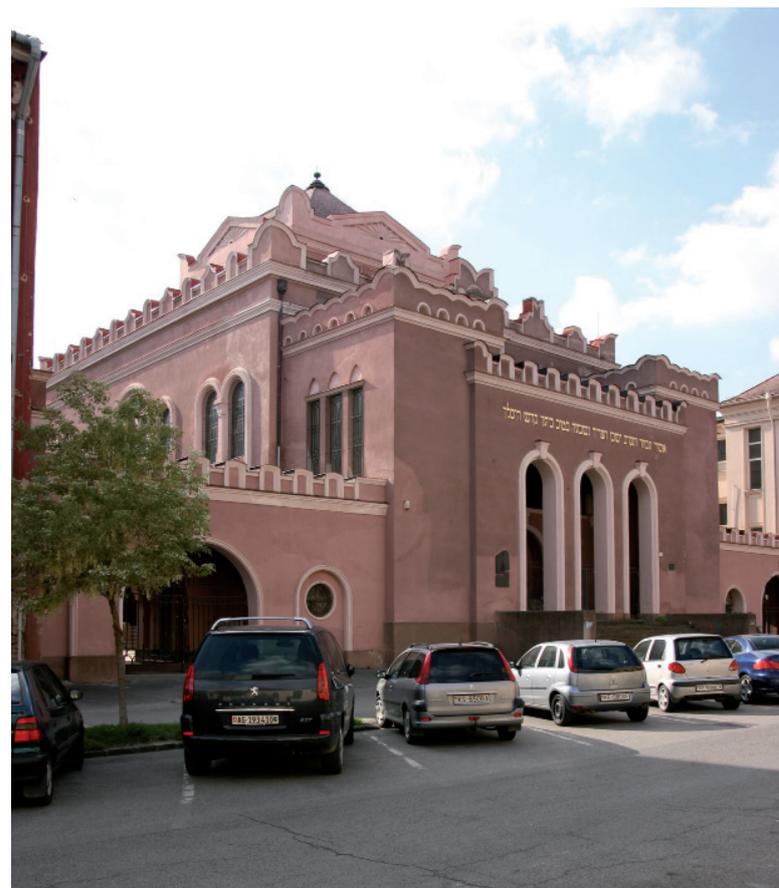
1. Synagogue and Jewish school (1926-1932), architect Ludovit Oelschläger, represent a distinctive variant of Kosice´s Modernism. Photo by Tibor Uhrín

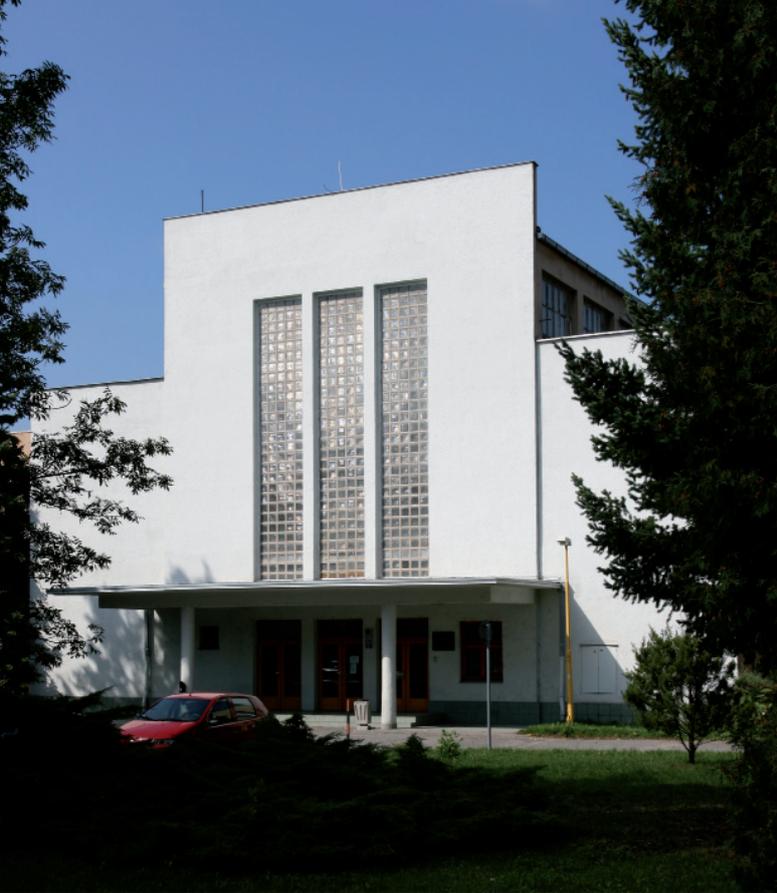
2. Czechoslovak Exhibition (1938), pavilion, now Mining Faculty of the Technical University in Kosice. Photo by Tibor Uhrin

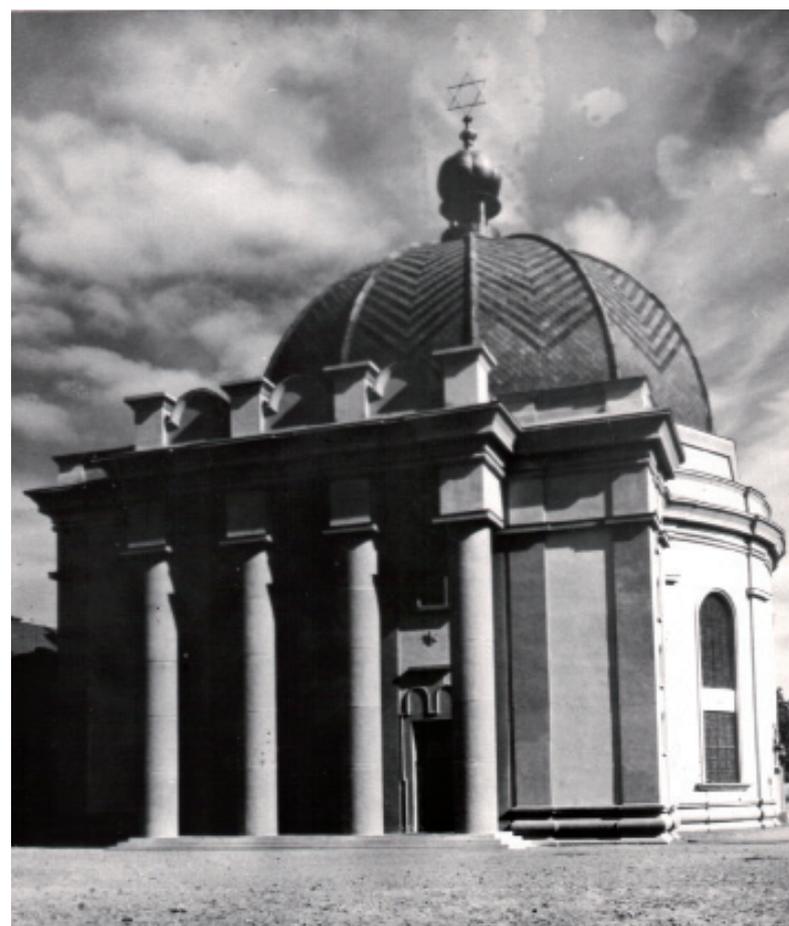
3. The neologic synagogue in Kosice, architect Lajos Kozma, 1927.

a large Jewish minority in the town; at the turn of the centuries three synagogues – prayer houses were used, but there was a need for a modern (neologic) one. An international competition was announced for the design – the winner was Lajos Kozma from Budapest. The building was finished in 1927 by the Building Company of Brothers Bárkány. The plan was using the shapes of the traditional Mauresque synagogue-style, but influenced by Modern Movement: round forms of alures, geometrical stucco decorations of interiors – quotation of universal classic motifs of porticus with a dome in a modern composition (the dome was not planned in the first design, but there was an effort of the Jewish community for the synagogue to reach the height of the cathedral in some way). The height of the dome is 35 m, not enough if compared with the tower of the cathedral ... There were 600 seats for men inside and 200 seats in the gallery for women. In the northern side of the synagogue a school building was completed for Torah-Talmudic studies.

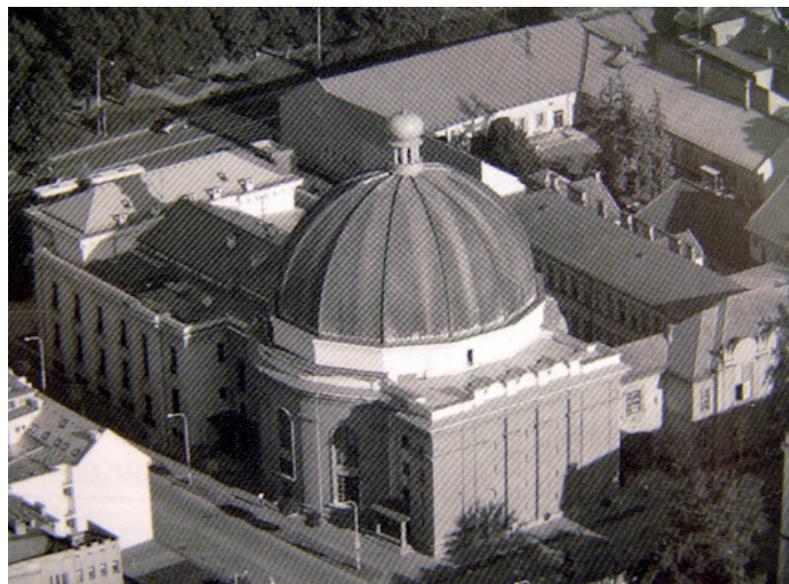
4. The neologic synagogue converted to a concert hall „The House of Art” in Kosice, rebuilt from the 1958 to the middle of the sixties of the 20th century.

architectural language – geometrical classicistic shapes (architect Czihal) – by enlarging the building the original round space under the dome was respected, but the former western portico was replaced by a substantial quadrate three-storey high western „annex” – the interior of it was connected to the central space of the former synagogue.

The western façade is now shaped with a portico with cubic columns – the change of the historicistic design toward a more fashionable sober elementary conception brought a new architectural value, in spite of the radical rebuilding, accented by high quality crafts-

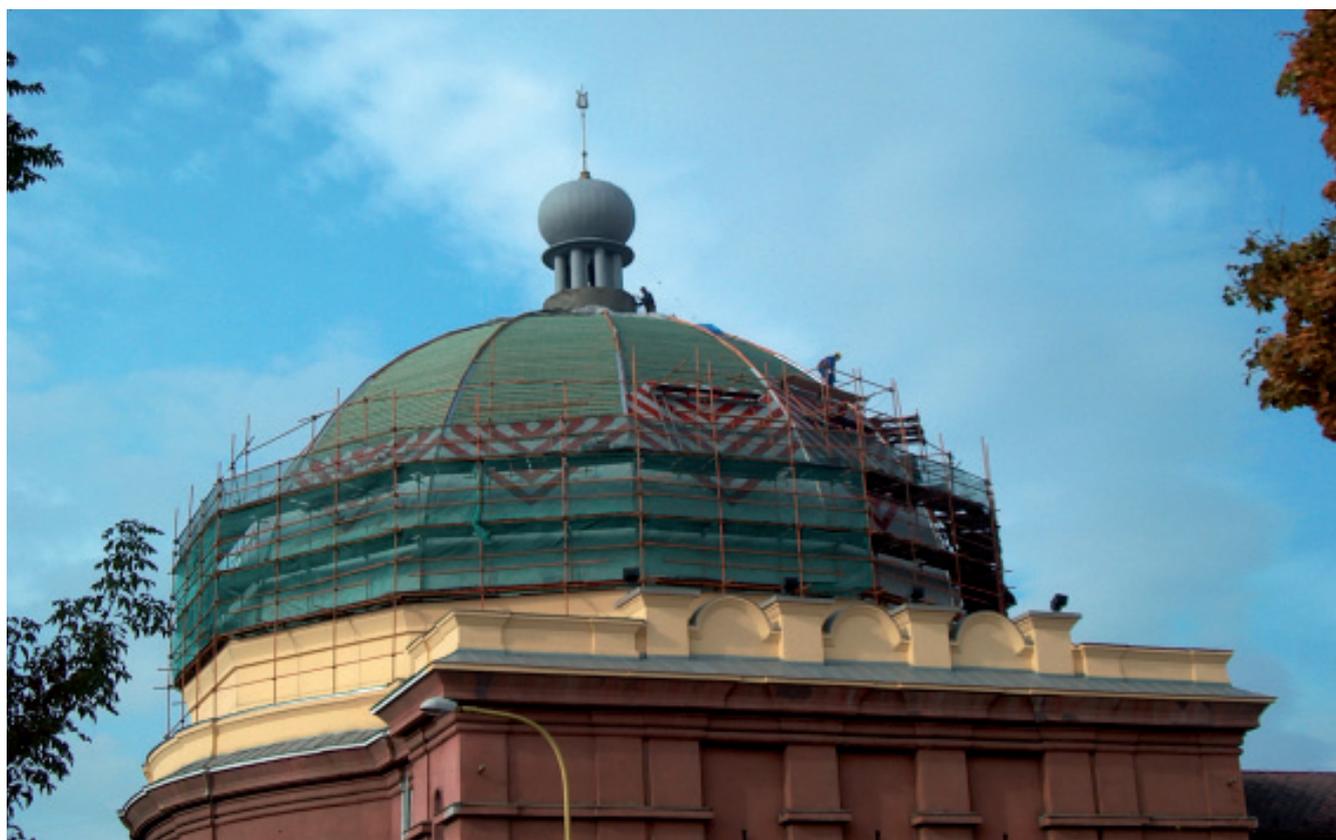
5. The reconstruction works on the roof of the dome in 2005. Photo by the author

The restoration began in May, 2003 with the careful repair of the roof covering – there were problems with removal of asbestos cement slates according to the requests of the EU: replacing the slates with Cembrit slates (the crown sheets of special size were produced for this purpose according to the original pieces), repair and conservation of the wooden roofing structure and sheet-coverings were completed in 2005. The interior of the dome was not damaged by any restoration work on the roof, the original fish-bone-pattern was renewed by the new covering. Plans for restoration and conservation work inside the building are being worked out now – they carefully maintain the original natural and artificial stone pavements and stairs, stucco decorations and exterior plasters, metal elements of staircases etc. The case of the House of Arts is an example of a well-prepared, careful and long-lasting heritage restoration.

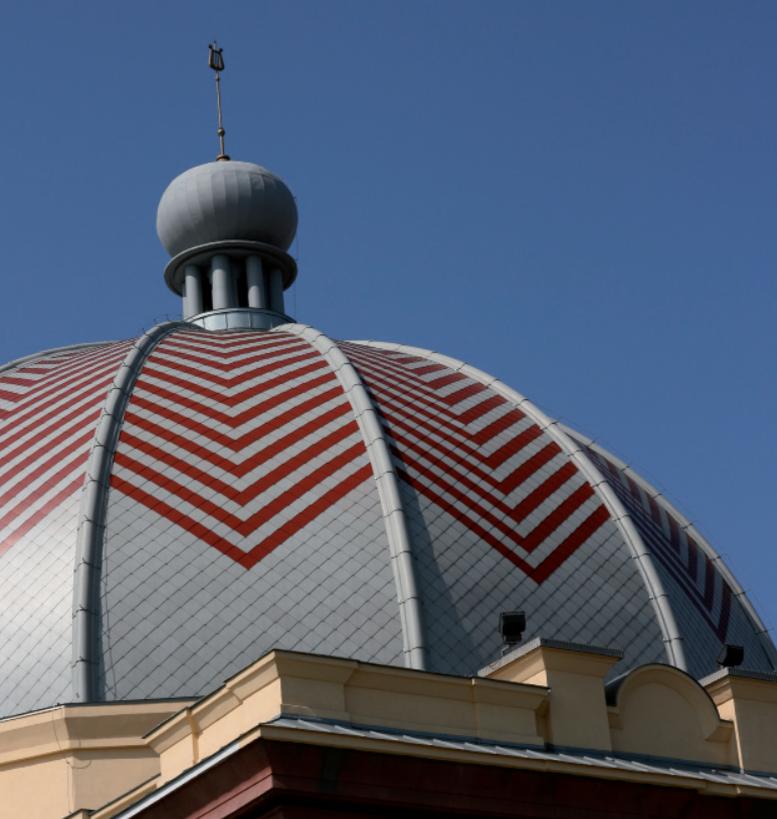
6. The dome roof after reconstruction. Photo by Alena Hrabinská

ceiling of the concert hall. The adaptation did not harm the dome and the roof construction of the original building. The roof covering was made from asbestos cement slates in grey and red colours, layed in a fish-bone-pattern, there were only small interventions in the lantern: the former Star of David was replaced by a sign of a harp as symbol of music.

And so the dome – its typical shape as a silhouette-dominante of the roofscape of the city centre – became an important object of the present heritage restoration. The lack of appropriate maintenance caused an urgent need of conservation. The present owner – the Town – and the user – the State Philharmonic of Kosice – began in 2003 restoration work, connected with creating new service rooms in the basement extension on the northern side of the building. This basement and semibasement will not disturb the exterior of the building, but enables better communication and usage of interior spaces.

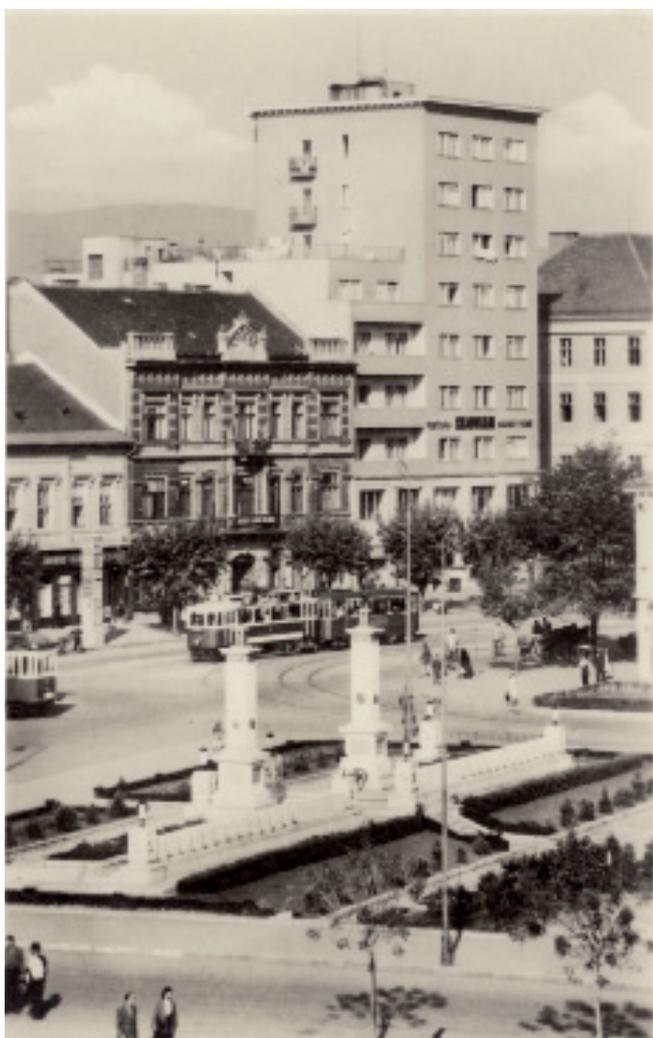
7. The „Nine-storey“ in Kosice, 1937-1939, architect Alexander Skuteczky, historical postcard.

This building is a historic high-rise in the city centre. At the time of its creation in 1939, thanks to its nine stories, it towered above the usually two-storey housing around (the highest buildings had four stories). The architect was Alexander Skuteczky (design from 1937) from Bratislava – the investor of the building was an Italian insurance company: Assicurazione Generali Triest. The requested inner space was divided into two bodies on both sides of the

corner: the six-storey part in the street-line is accented by the nine-storey high-rise at the corner: the ground floor and the 1st floor are for commercial use (shopping and administration), the other (higher) floors are used for flats.

The different inner function is presented in the exterior by two-storey travertine wainscot contrasting with the smooth plaster surface of the floors with flats. The framing of doors and windows in the ground floor is made of metal, but the flats have wooden frames. The facades of the flats have continuous recessed balconies (loggia) and from the sixth floor of the „tower“ there is an entrance to the terrace on the roof of the lower part, originally accessible to everybody living in the house. The floors with flats have two staircases and elevators – one on each side.

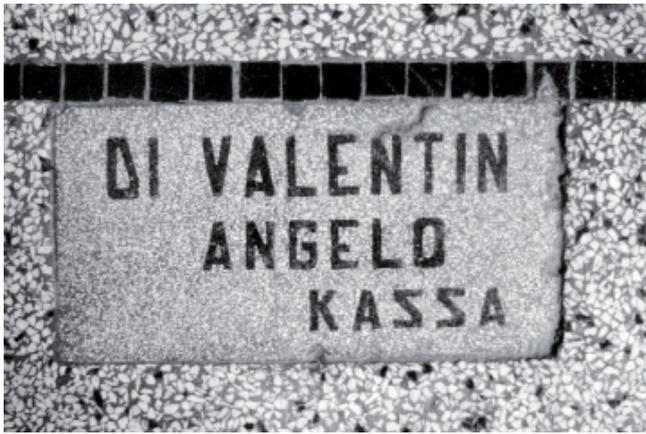
8. Detail of terrazzo pavement with Valentin di Angelo's signature in the entrance hall of the „Nine-storey“. Photo by Gabriel Kladek

A number of original authentic details have survived in the interior – in flats, staircases and entrance halls as well. There are admirable details of artificial stone, produced by a well-known craftsman in Kosice – Angelo di Valentin (of Italian origin). A lot of veneered interior flat-doors have remained in the house, combined with authentic details: doorhandles, eyelets, special metallic handrails and travertine sheeting of breasts in the staircases.

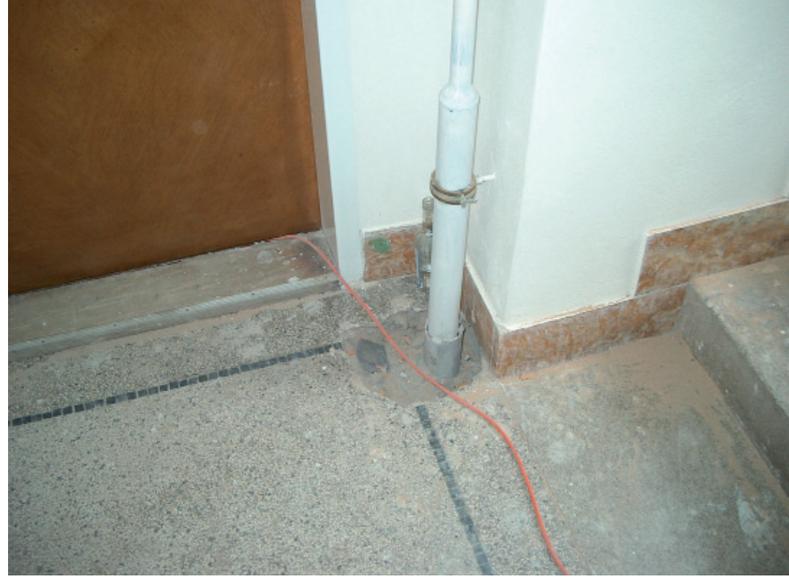
9. Detail of terrazzo pavement destruction in the interior of the main staircase during the reconstruction. Photo by the author

changing of the original corridor connecting the two main staircases. The process of this type of “restoration” illustrates the nonsense of modernisation, during which recent quality handicraft is replaced by what is fashionable today (e.g. terrazzo pavements or artificial stone elements, “repairing” veneered interior doors by giving them a coat of paint in various colours, replacing well-kept stone-sheeting with new travertine instead of cleaning and conserving the original one. The owner planned to replace all

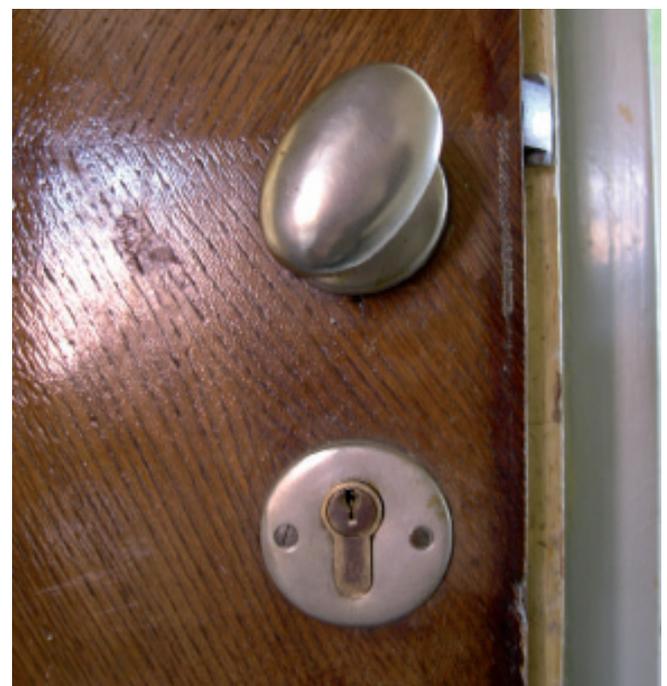
10. Detail of original door with a Functionalistic knob. Photo by the author

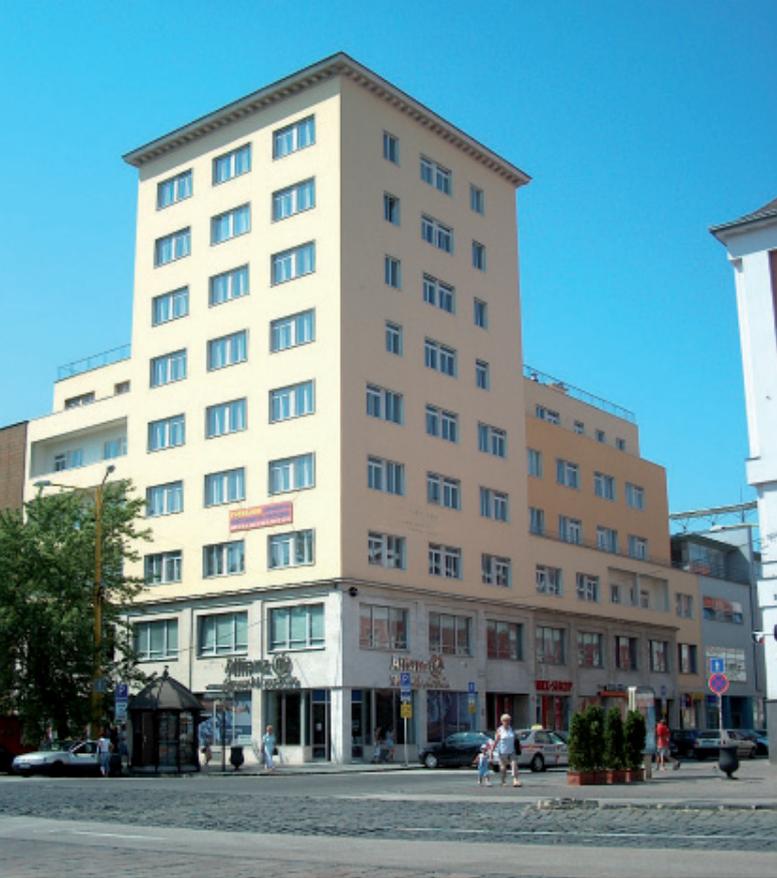
11. The „Nine-storey“ after reconstruction – present state.
Photo by the author

After restoration the building seems to be well-kept, maintained as a whole unit, without principal changes, and in spite of the number of removed or destroyed details it still represents a historical tenement house with flats in higher floors and with commerce and administration in the ground floor and 1st floor. But the truth is that most flats are still empty and there are more and more firms and companies stepping quietly into the house and occupying some flats for administrative purposes, too.
