# Current Needs versus Selected Problems of Conservation Work in Modernist Buildings

**Andrzej Białkiewicz**  
*Cracow, Poland*

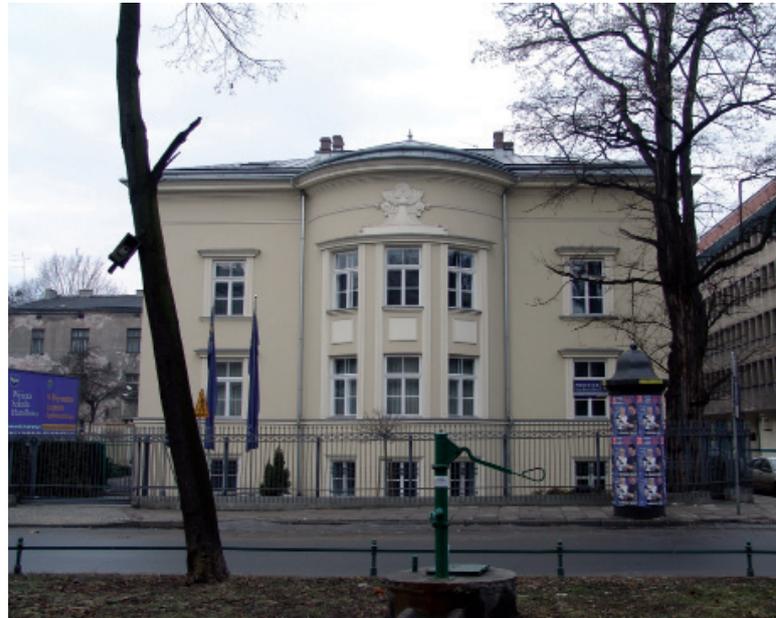
**1.** Tenement at the corner of streets Retoryka and Smoleńsk in Cracow, Waclaw Krzyżanowski 1922, eastern elevation. Photo by the author

Krzyżanowski<sup>1</sup> in 1922, it was completed in the same decade. This is a three-storey building on a practically square plan, with a semi-circular protruded bay window in the façade, all covered with a hip roof that cannot be seen from street level. The building has a classical form, yet with clearly seen modernistic elements. The details – columns and pilasters – have been reduced to the minimum; they are but a delicate feature in the elevation. Indigenous elements should be noted, especially Neo-Empire and Neo-Baroque decoration. The horizontal layout is stressed by

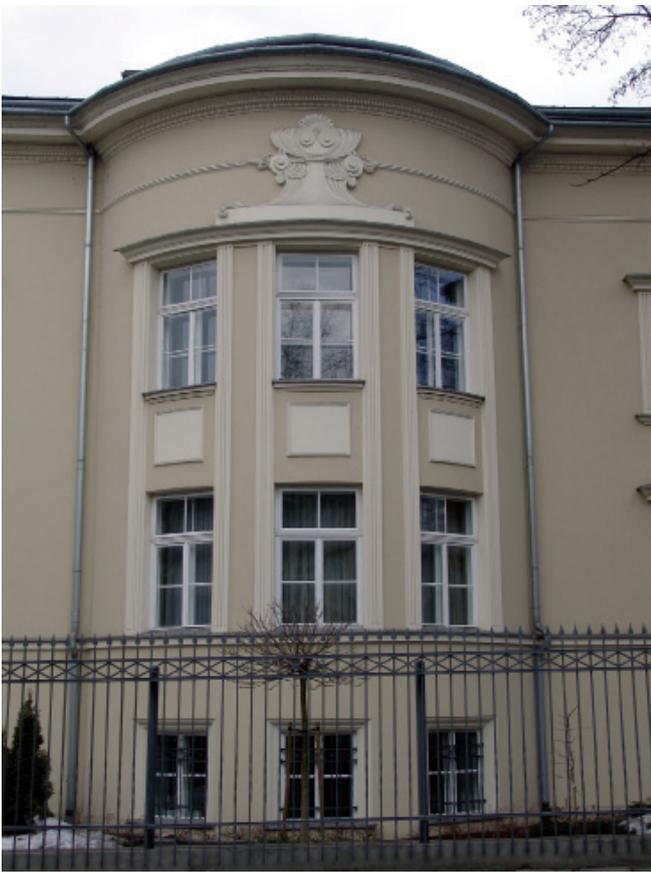
**2.** Tenement at the corner of streets Retoryka and Smoleńsk in Cracow, Wacław Krzyżanowski 1922, eastern elevation – the bay window. Photo by the author

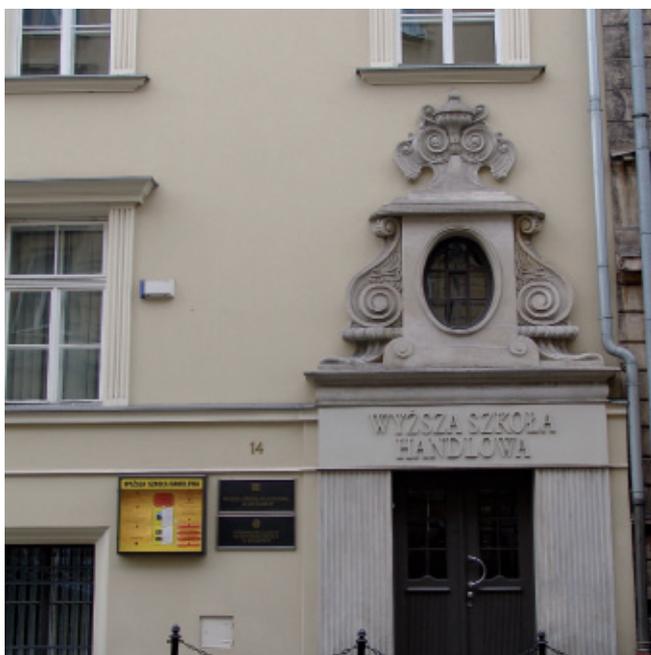
**3.** Tenement at the corner of streets Retoryka and Smoleńsk in Cracow, Wacław Krzyżanowski 1922, northern façade – the portal entrance. Photo by the author

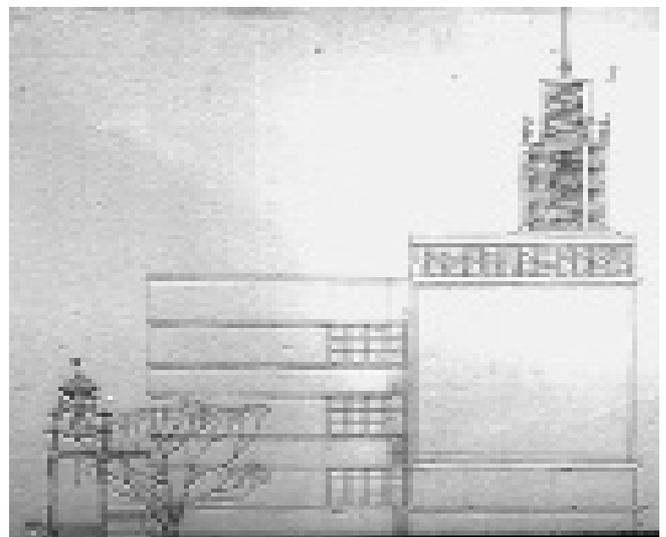
**4.** Pauline Fathers' Seminary in Skalczna street in Cracow, Adolf Szyszko-Bohusz 1931, the first design (not approved for construction), western elevation. Source: Pauline monastic archives at Skalka in Cracow.

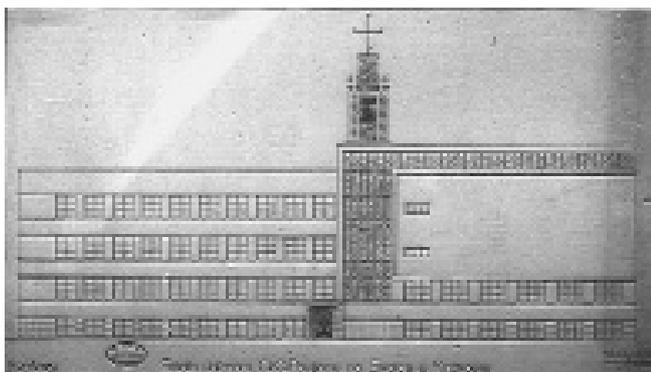
**5.** Pauline Fathers' Seminary in Skaleczna street in Cracow, Adolf Szyszko-Bohusz 1931, the first design (not approved for construction), northern elevation. Source: Pauline monasterial archives at Skalka in Cracow.

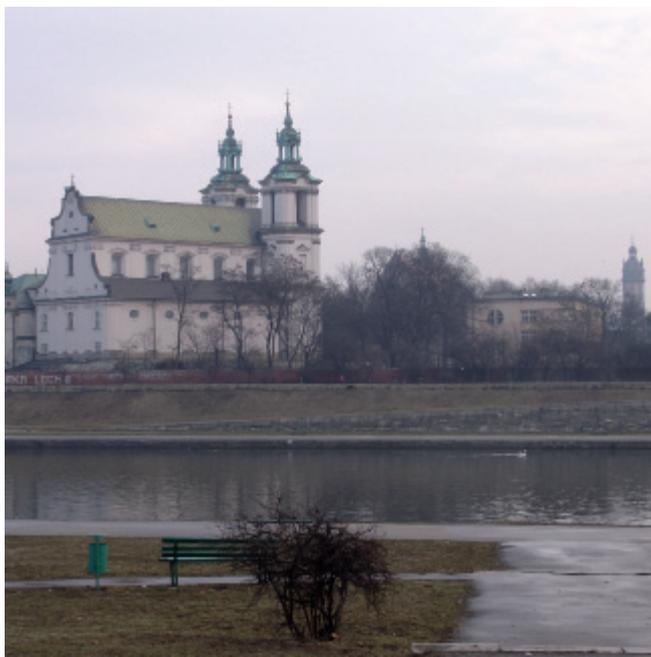
**6.** Pauline church and seminary in Skaleczna street in Cracow, Adolf Szyszko-Bohusz 1931, western elevation. Photo by the author

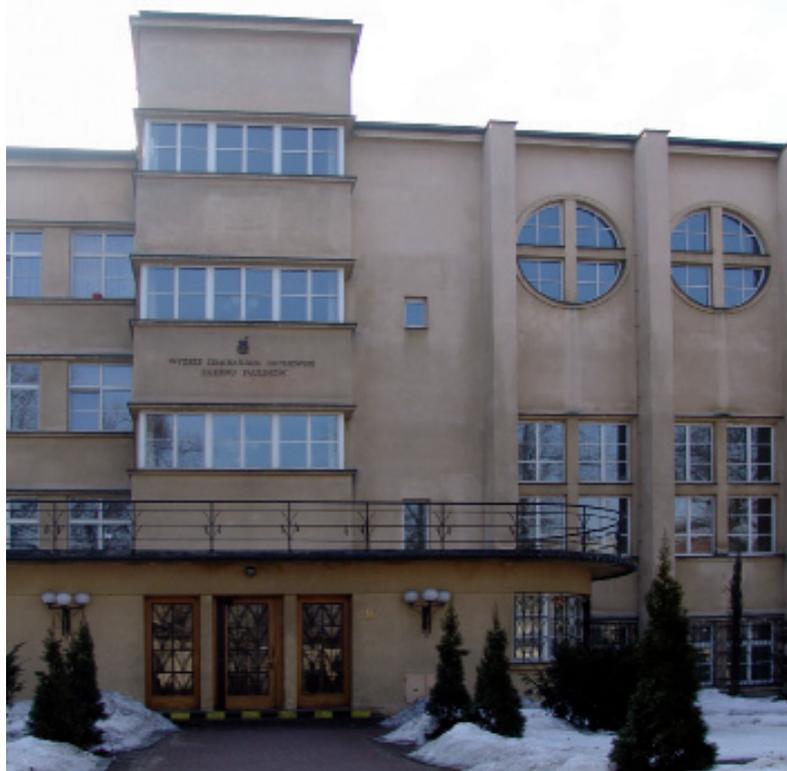
**7.** Pauline Fathers' Seminary in Skaleczna street in Cracow, Adolf Szyszko-Bohusz 1931, northern façade with entrance and chapel. Photo by the author

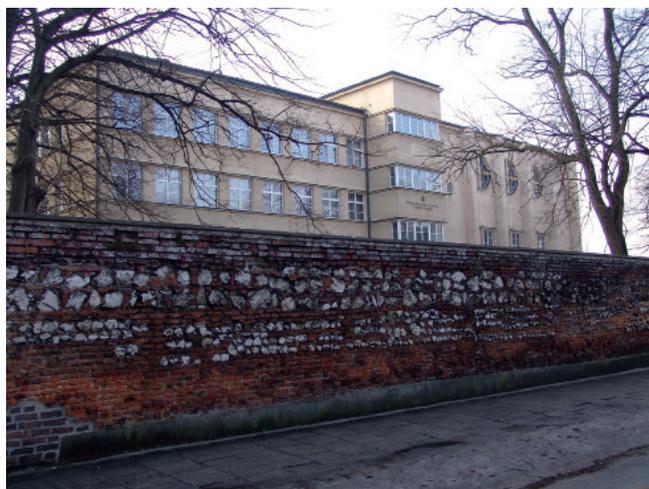
**8.** Pauline Fathers' Seminary in Skaleczna street in Cracow, Adolf Szyszko-Bohusz 1931, northern façade. Photo by the author

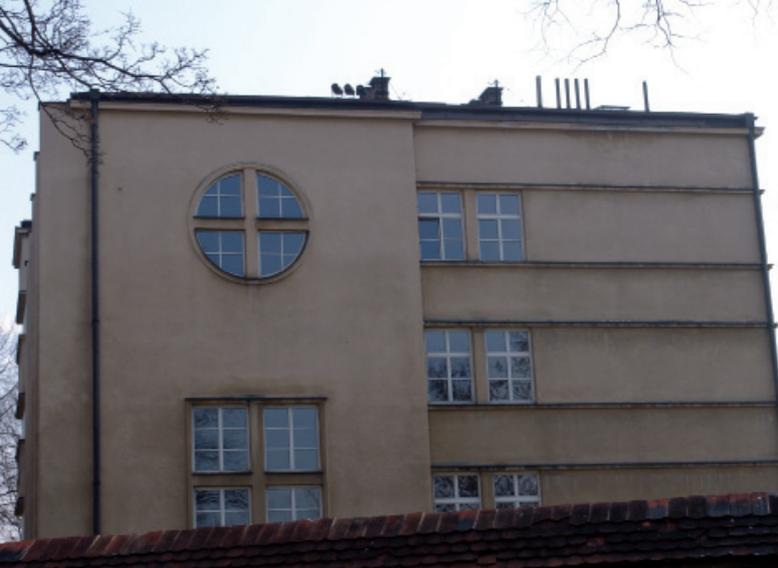
**9.** *Pauline Fathers' Seminary in Skąpczna street in Cracow, Adolf Szyszko-Bohusz 1931, part of western elevation. Photo by the author*
