Juliusz Żórawski's Glass House in Warsaw - 73 Years Later

Andrzej K. Olszewski

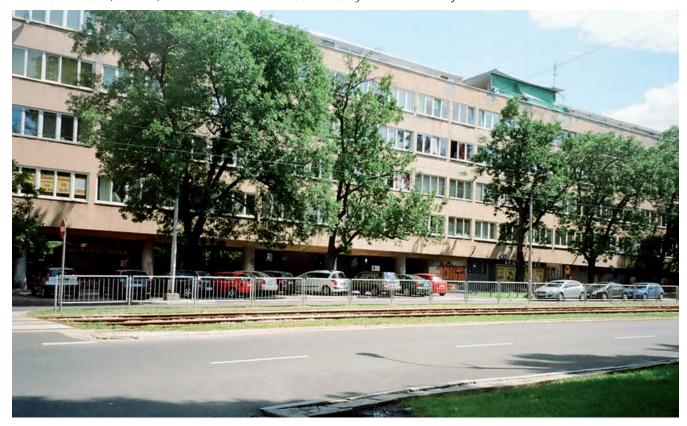
1. The Glass House, Warsaw, view from Mickiewicza Street. Photo by Irena and Andrzej Olszewski

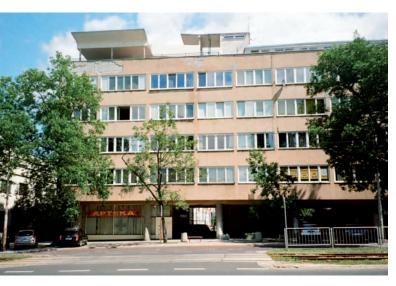
2. The Glass House, view from Mickiewicza Street. Photo by Irena and Andrzej Olszewski

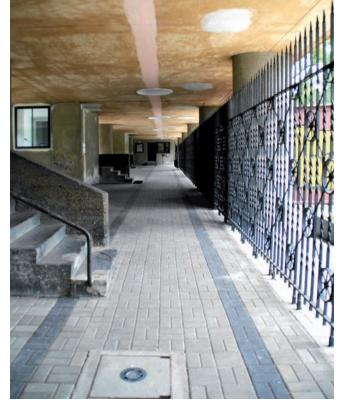
3. Arcades from the side of Mickiewicza Street. Photo by Irena and Andrzej Olszewski

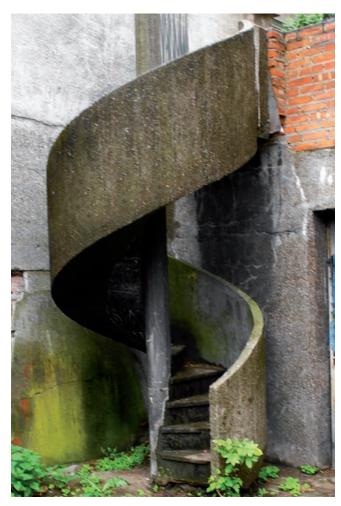
6. Stairs to the garage. Photo by Irena and Andrzej Olszewski

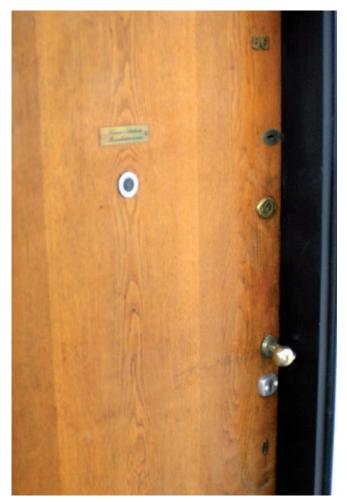
7. Refurbished door. Photo by Irena and Andrzej Olszewski

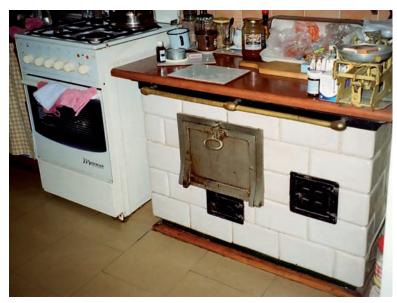
8. Original coal stove and gas cooker. Photo by Irena and Andrzej Olszewski

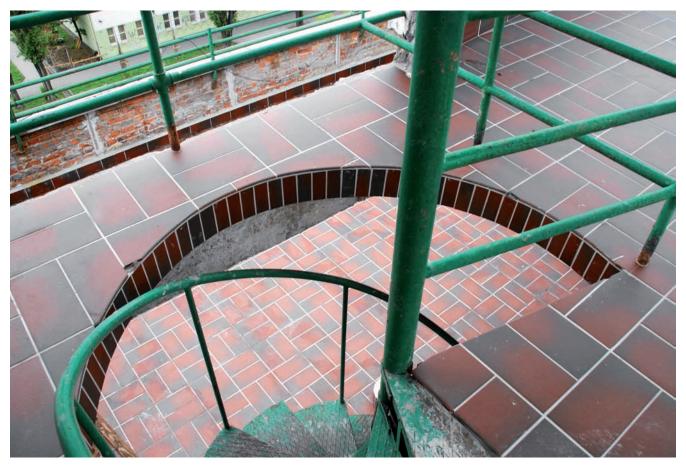
9. Refurbished terrace stairs. Photo by Irena and Andrzej Olszewski
